CASE STUDY

CADDO CREEK

Carter County, Oklahoma
Submar Project 13720.2

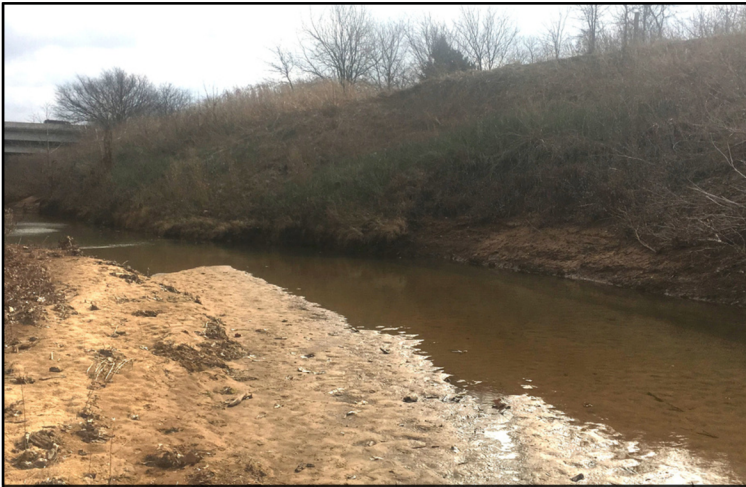
BEFORE

An 8-inch natural gas pipeline crosses Caddo Creek in Carter County, Oklahoma. The bed and banks of the creek are composed of clay and sand and the banks are well vegetated. Heavy rain caused lateral migration and head cutting that eroded the right descending bank. This erosion exposed the pipeline for 7 feet at the toe of the bank.
