CASE STUDY

HOLLY FORK CREEK

Morehead, Kentucky
Submar Project 698

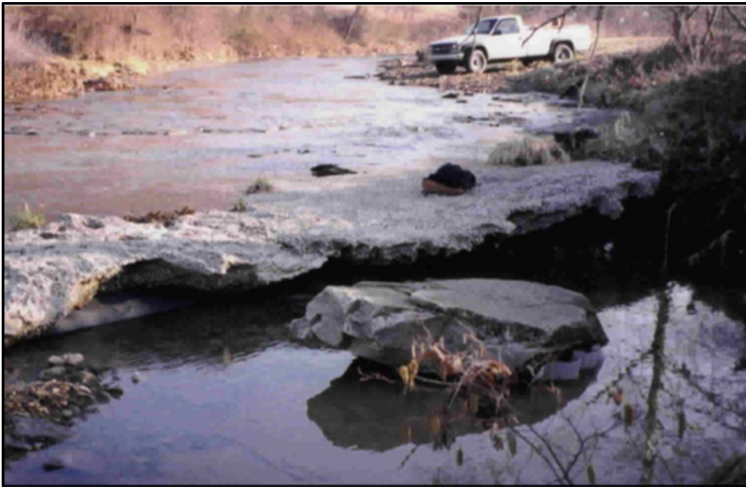
BEFORE

Holly Creek crosses a 30" gas transmission pipeline at nearly a 45° angle. The pipeline has a concrete cap poured on top to provide cover. The creek bed has degraded downstream of the pipeline, and the pipeline is exposed along the left bank. The concrete slab is resting on the pipeline. The creek bed is composed of rock, and the banks are rocky soil. Rock material and large debris flow down the creek and over the pipeline on a regular basis.

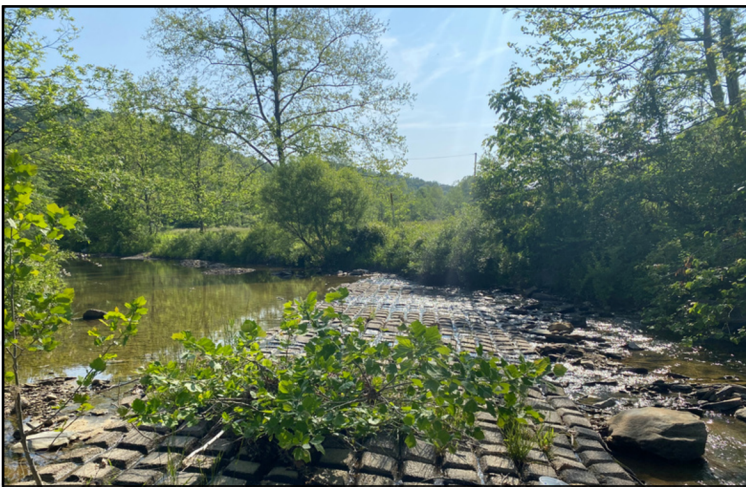
AFTER

The "AFTER" photo was taken in 2023.

The concrete cap was removed and replaced with a system of articulating concrete mats. The creek banks were graded back to a stable slope. The mats were anchored into the rock bed upstream of the pipeline.
