CASE STUDY

UNNAMED WASH

New Mexico

Submar Project 13500

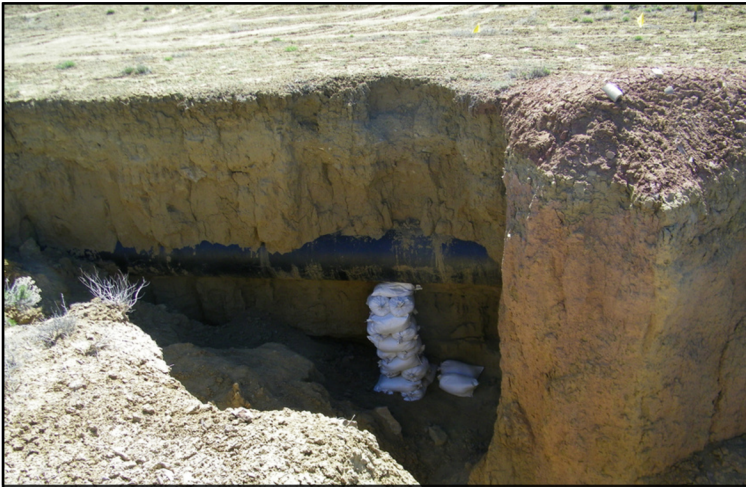
BEFORE

EXISTING CONDITIONS

A 15-foot deep erosion rill had formed in an unnamed wash due to storm water flows, exposing one of four natural gas pipelines in the area. If left uncovered and unprotected, the pipeline risked further exposure and potential damage due to continued erosion.
