CASE STUDY

DRIP STATION

Beaver County, Pennsylvania
Submar Project 16024

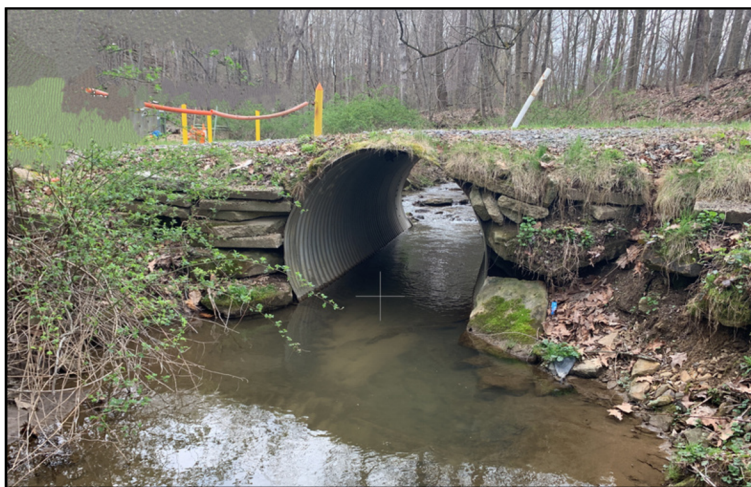
BEFORE

A 4-inch natural gas pipeline crosses Brush Run in Beaver County, Pennsylvania in a 40-foot wide right-of-way. The channel bed is composed of clay and rock, while the banks are composed of clay and sand. A 10-inch pipeline is located upstream and a 2-inch abandoned pipeline is located downstream of the 4-inch pipeline. The pipeline is located next to a 72-inch culvert, which bridges across the channel and leads to a drip station for a production well and valves. A riffle station was installed downstream. Headcutting in the stream has exposed the pipeline for 3 feet and the abandoned line for 11 feet.
