CASE STUDY

# FAIRHAVEN

Allegheny County, Pennsylvania  
Submar Project 16588

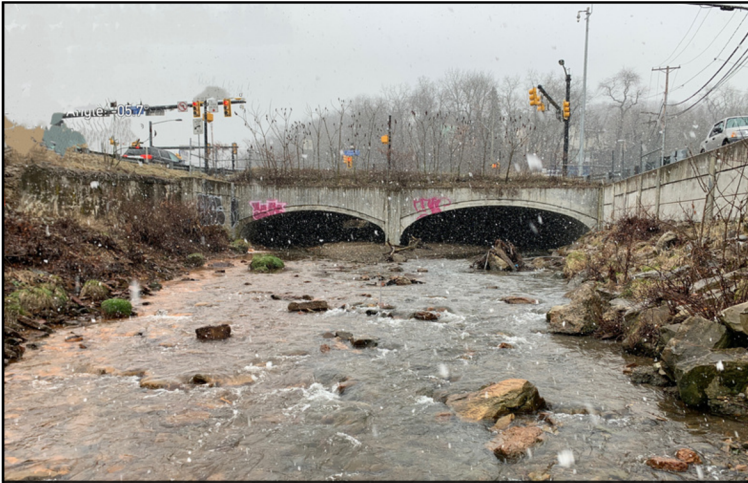
**BEFORE**

A 16-inch natural gas pipeline crosses Sawmill Run in Allegheny County, Pennsylvania in a 40-foot wide right-of-way. The channel bed is composed of rock and gravel, and riprap lines the banks. The Department of Transportation had installed new box culverts directly upstream of the pipeline, and sediment had gathered in the box culverts. An unstable retaining wall was located downstream of the pipeline on the right-descending bank. Headcutting and bed degradation had exposed the pipeline for 29 feet.
