CASE STUDY

LITTLE SANDY CREEK

Pontotoc County, Oklahoma
Submar Project 14616

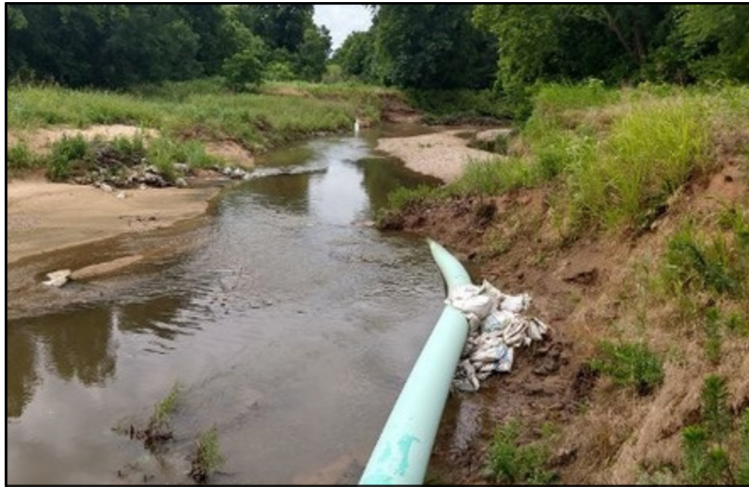
BEFORE

A 20-inch natural gas pipeline crosses Little Sandy Creek in Pontotoc County, Oklahoma. The creek bed is composed of clay, sand, gravel, and riprap. Broken concrete was previously placed on the right-descending bank but has scattered. The meandering creek and sheet flow have degraded the banks. The pipeline is exposed for 110 feet near the right-descending bank and 20 feet near the left-descending bank.
