THE Exposed Pipeline Remediation Experts

EXISTING CONDITIONS

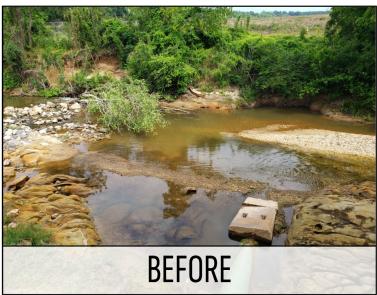
A 24-inch natural gas pipeline crosses Little Mulberry Creek in Chilton County, Alabama in a 50-foot wide right-of-way. The soil in the creek bed is composed of clay and sand, and the banks are well-vegetated with trees and grass. Headcutting in the stream has degraded the bed, eroding away the sand layer, and exposing the pipeline for 10 feet. The landowner had placed riprap in the stream to prevent erosion and to facilitate a pump in the stream. Smaller pieces of riprap have moved due to high flow. Further, river weights were located on top of the pipeline.
