CASE STUDY

STITT ROAD

Beaver County, Pennsylvania
Submar Project 16023

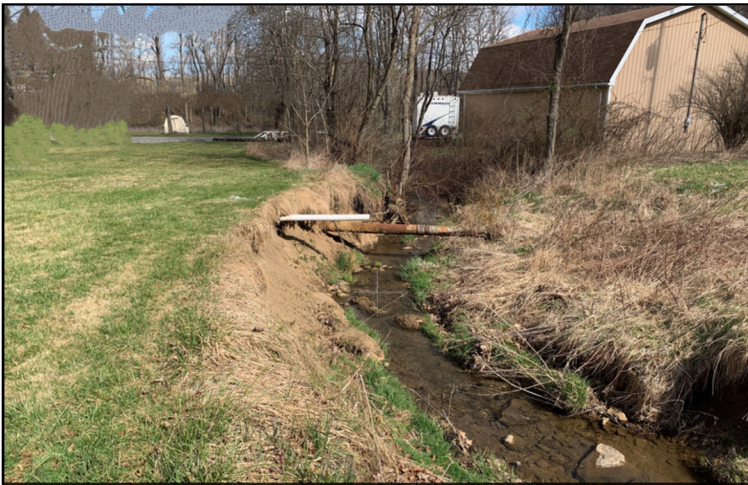
BEFORE

A 10-inch natural gas pipeline crosses a tributary to Dilworth Run in Beaver County, Pennsylvania in a 25-foot wide right-of-way. The soil is composed of clay with rock in the channel bed and well-vegetated banks. A 6-inch abandoned pipeline is located downstream and a 4-inch drainage line is located upstream of the 10-inch pipeline. Headcutting in the stream has left shallow cover over the pipeline and exposed the abandoned pipeline for 16 feet.
