## THE Exposed Pipeline Remediation Experts

## **EXISTING CONDITIONS**

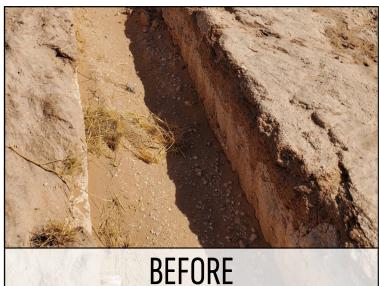
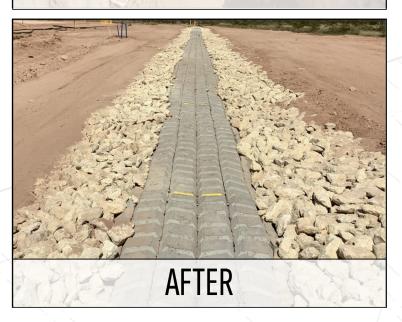
A 50-foot-wide pipeline right-of-way (ROW) had one 16-inch diameter natural gas pipeline in Lea County, New Mexico. Two sites, located 400 yards apart on the same pipeline, were being eroded directly over the pipeline ROW trench. Water running along the trench degraded the depth of cover on top of and adjacent to the pipeline at both sites. This created two long pipeline exposures immediately adjacent to the access roadway.trenches that were backfilled with existing material and rip rap, and final grading was performed.

The site was graded, anchor trenches were dug, and geotextile fabric was placed on top of the grade. A Submar articulating concrete mattress system was installed over the geotextile fabric and the mats were banded together. A total of 67 mats were installed at the two sites.

The upstream, downstream, and flank edges of the mat system were toed into excavated anchor trenches that were backfilled with existing material and rip rap, and final grading was performed.
