EROSION CONTROL

Banking on It

Techniques for streambank repair and stabilization

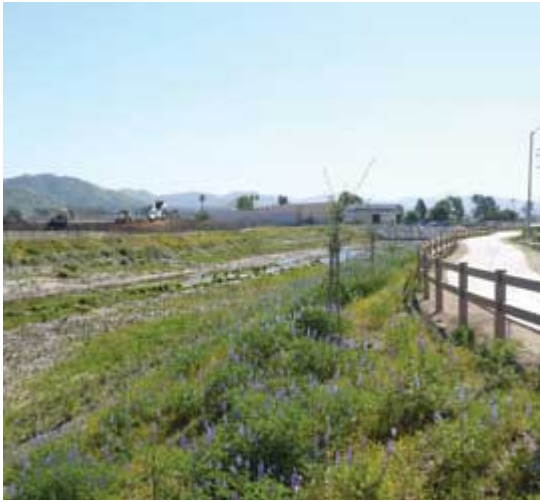
Photo: City of Santee
Forester Creek in Santee, CA, after a full revegetation

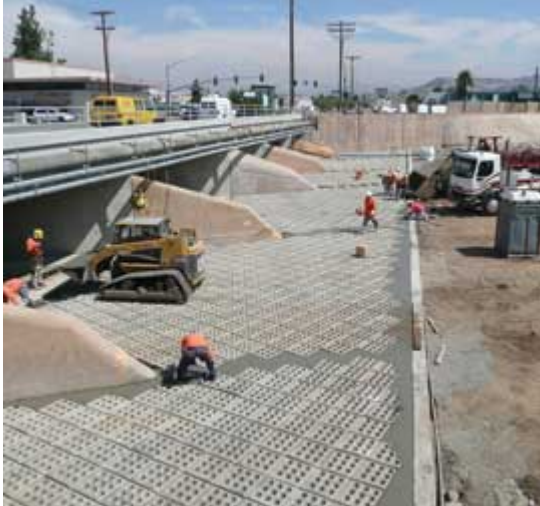
Photo: Soil Retention
Articulated concrete blocks reinforce the channel bottom.

Articulated blocks were used to reinforce the channel bottom. Enviroflex, manufactured by Soil Retention Inc. of Carlsbad, CA, helps provide erosion resistance while adapting to ground movements and grade changes. Openings in the block units allow vegetation establishment.

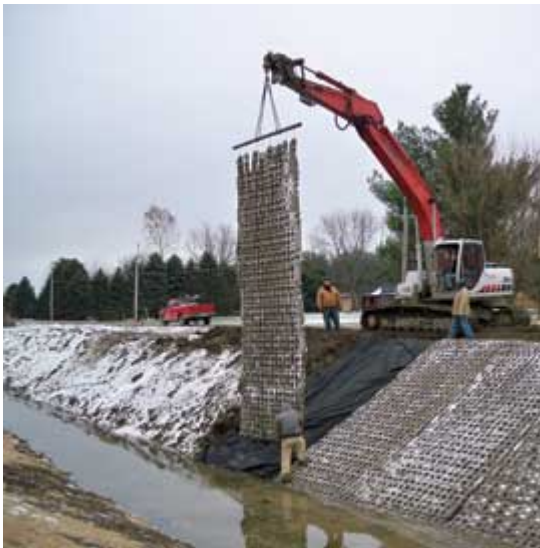
Photo: Charles E. Leser, Madison County
The Indiana Department of Environmental Management
required articulated concrete block mats for the bridge.

“The normal practice is to place riprap with filter fabric underneath it,” says Leser. But IDEM requires the use of articulating concrete block mats.

The outside and inside curve bank needed to be protected from erosion. Therefore, approximately 3,550 square feet of **UltraFlex Class M4540 articulating concrete block mat** was chosen to provide the solution.

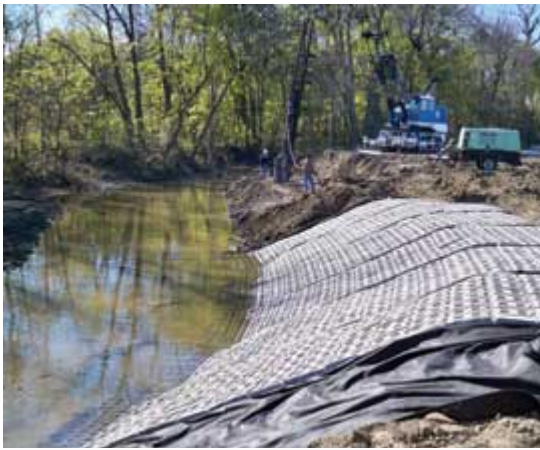
Photo: Charles E. Leser, Madison County
The mats that were used had about a 20% open area through which vegetation could grow.

After the stream was relocated, contractor A. K. Shannon Excavating of Gwynneville, IN, installed filter fabric and laid the mats on top, covering them with dirt and then seeding them. The mats have about a 20% open area through which vegetation can grow.

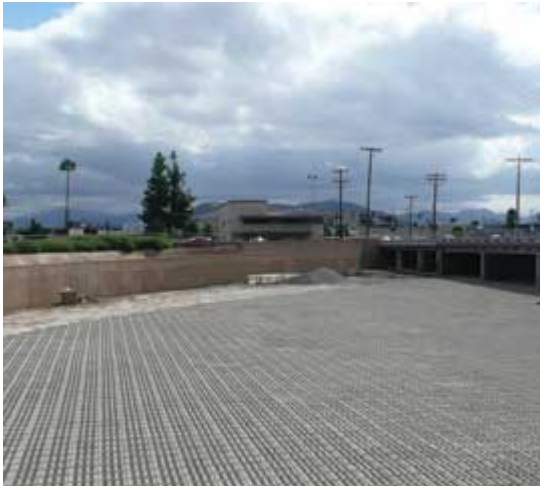
Photo: Soil Retention
The newly restored Forester Creek channel can accommodate a 100-year flood.

The channel had to be widened to 200 feet—three times its original size—to accommodate stormwater flows. The depth of 10 to 15 feet was retained, as well as the creek's slope.
