## THE Exposed Pipeline Remediation Experts

## **EXISTING CONDITIONS**

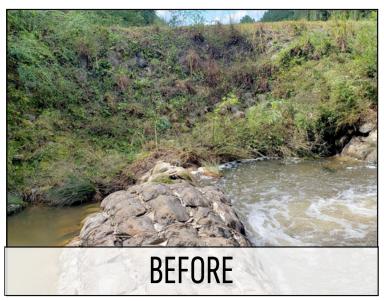
A 150-foot wide pipeline right-of-way contained four natural gas pipelines with diameters of 42 inches, 30 inches, and two 36 inches. The two 36-inch pipelines crossed Big Swamp Creek in Covington County, Mississippi. The two 36-inch pipelines had a preexisting grout mat system that had failed due to heavy rain, and the grout mats were dangling from them with a 12-foot plunge pool in between. The soil and banks were composed of clay, sand, and gravel, and they were heavily vegetated with grass and trees.

The project area was dewatered and graded to yield gentle slopes less susceptible to erosion. A geotextile material was placed atop the grade, followed by the Submar articulating concrete mat system which extends across the channel from bank to bank.

The upstream, downstream, and flank edges of the mat system were toed into anchor trenches that were backfilled with existing material and rip rap.

Downstream of the mat system, a riprap subgrade was installed to prevent headcutting from progressing upstream.

Riprap was placed on the banks to prevent further lateral migration upstream and downstream of the mat system. Upon completion of final grading, seed and straw were placed on the disturbed areas of the site to aid in a rapid return to preconstruction vegetative conditions.
