CASE STUDY

HEFFNER HOLLOW

Tioga County, Pennsylvania
Submar Project 18092

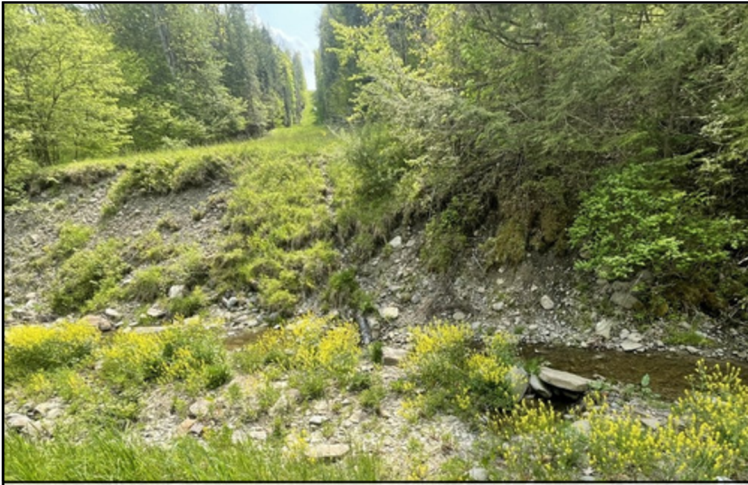
BEFORE

An 8-inch natural gas pipeline crosses an unnamed creek in Tioga County, Pennsylvania in a 50-foot wide right-of-way. The creek bed and banks are composed of clay and rock. The right descending bank of the creek has been eroded due to flooding creating an 8-foot pipeline exposure. Further, the right bank is about 12 feet tall with several slips due to high water that has undercut the bank.
