THE Exposed Pipeline Remediation Experts

EXISTING CONDITIONS

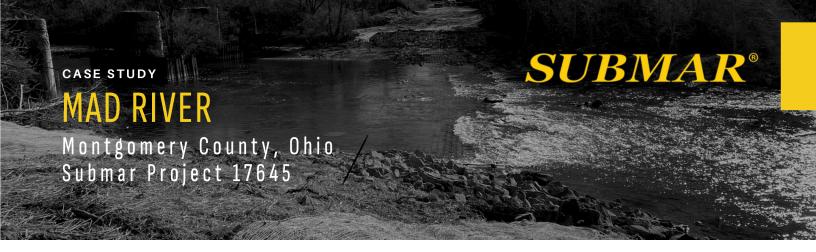
A 50-foot wide pipeline right-of-way contained one 8-inch diameter pipeline inside of a 10-inch casing. The pipeline was exposed across the entire 130-foot Mad River crossing in Montgomery County, Ohio. The pipeline was also suspended over a 5-foot deep by 30-foot long scour hole. The river bottom and banks were composed of clay, sand, and gravel.

A divert, dewater, and construction plan was implemented in two phases due to the width of the river. For phase 1, 8-foot wide by 100-foot long water dams and sandbags were installed over the pipeline. The water dams were filled and the area inside the water dams was dewatered with pumps.

The channel bank and streambed were graded and anchor trenches were dug in preparation to install erosion control materials. A Submar articulating concrete mattress system was installed over geotextile fabric and the mats were banded together. A riprap subgrade and grade control were installed over geotextile fabric.

After phase 1 of the project was completed, the dams were removed and installed in the same manner on the opposite side for phase 2 of the project, which was completed in a similar fashion. After phase 2 was complete, final grading was performed, and seed and straw were placed over the disturbed areas to aid in a rapid return to preconstruction vegetative conditions.
