CASE STUDY

MAMMOTH WASH

Imperial County, California
Submar Project 14018

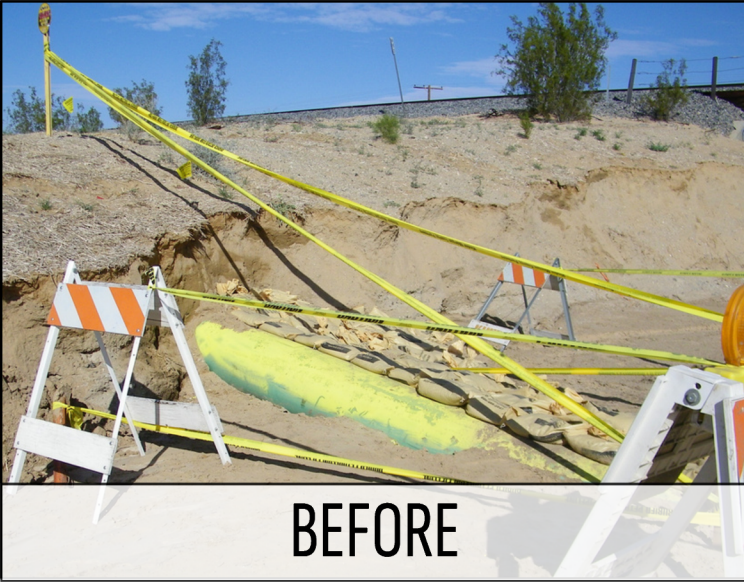
BEFORE

20-inch products pipeline runs parallel to a railroad track in Imperial County, California. Both the pipeline and the railroad are crossed by the 250-foot wide Mammoth Wash. Flash floods caused lateral migration and eroded 3 to 6 feet of the right-descending bank. This erosion exposed the pipeline for 15 feet at the toe of the bank. The soil in this area is composed of silty sand and gravel, while the terrain is sparsely vegetated with buckwheat, witch grass, dune primrose, and verbena.

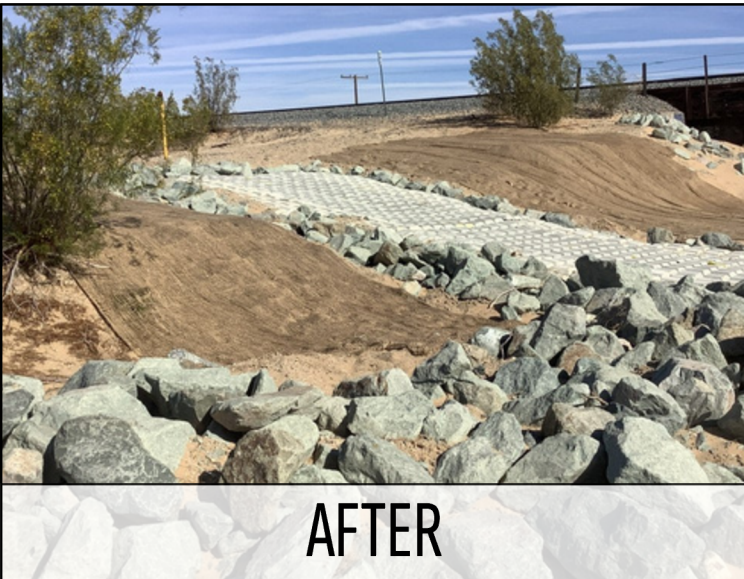
AFTER

The exposed pipeline was covered with additional compacted soil that was graded to a gentle slope. A Submar articulating concrete mat system was installed to armor the pipeline. All edges of the mat system were toed into anchor and flank trenches that were backfilled with existing material and rip rap. Additionally, a Longitudinal Peaked Stone Toe Protection (LPSTP) system was installed to prevent future toe and bank erosion. Final grading was performed to restore the disturbed area to pre-existing contours.
