CASE STUDY

MIAMI STREET CANAL

Miami, Florida
Submar Project 14236

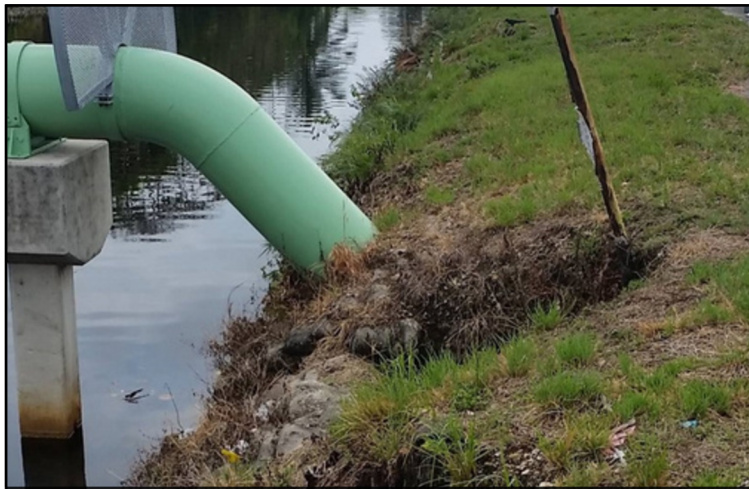
BEFORE

A 6-inch diameter natural gas pipeline crosses a canal in Miami, Florida. Sheet flow from the adjacent street and high flow events had exposed the pipeline. 3-in-1 concrete bags had been placed atop the pipeline in an effort to protect it, but the sheet flow and high flow events had removed cover behind the bags. If left unprotected, the pipeline risked further exposure and possible damage.

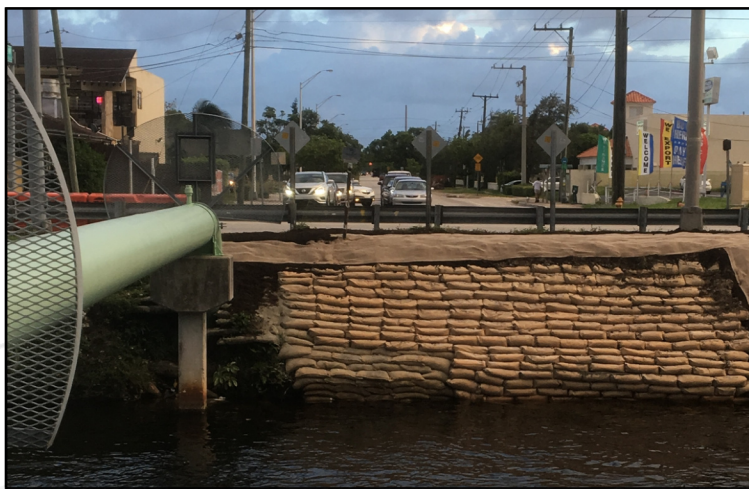
AFTER

Submar proposed reinstalling 3-1 concrete bags on the banks with additional erosion control measures. Prior to construction, a silt curtain was installed to control sediment in the canal and contain it a few feet away from the water surface. The toe of the bank was then excavated to allow the installation of geotextile fabric beneath the new 3-1 bags to minimize settlement, and the existing concrete bags were hauled off the site.

The project area was backfilled with granular fill and covered with a non-woven geotextile fabric liner. The new 3-1 concrete bags were placed on the bank and conformed to the existing bank slopes before and beyond the installation areas to avoid causing eddies. Rebar was driven through the sand-cement riprap to secure the bags. The silt curtain was removed after construction, and curlex and seed were placed on the final grade.
