THE Exposed Pipeline Remediation Experts

EXISTING CONDITIONS

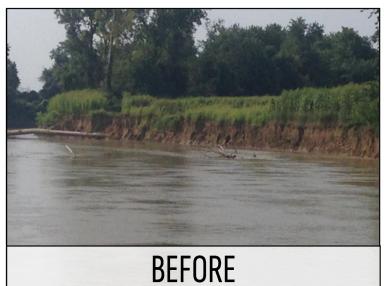
A 30-inch diameter natural gas transmission pipeline crosses at the confluence of the White River and the East Fork of the White River. The White River had laterally migrated and the right, descending, high bank eroded to expose the pipeline. The 30-inch pipeline span grew to a length of over 80' and extended into the main river channel. Large trees and debris were common in the river channel due to upstream bank erosion. These trees and debris threatened to strike and entangling on the pipeline.

A pipeline support was installed to stabilize the pipeline span prior to backfill operations. The backfilled area that extended into the main river channel was armored with a system of Submar articulating, concrete, revetment mats. A longitudinal peaked stone toe protection (LPSTP) system was installed from a stable point upriver along the right toe for an approximate length of 1,500 feet. LPSTP is used to protect the toe of the banks from erosive scour, arresting future lateral migration.

Multiple redirective structures, bendway weirs, were installed along the right, toe, extending from the LPSTP. The bendway weirs direct the flow and maintain the thalweg location away from the right bank. The right bank was then graded and live stakes were installed along with jute netting.
