## CASE STUDY

# ANACOSTIA RIVER

Silver Spring, Maryland  
Submar Project 12846

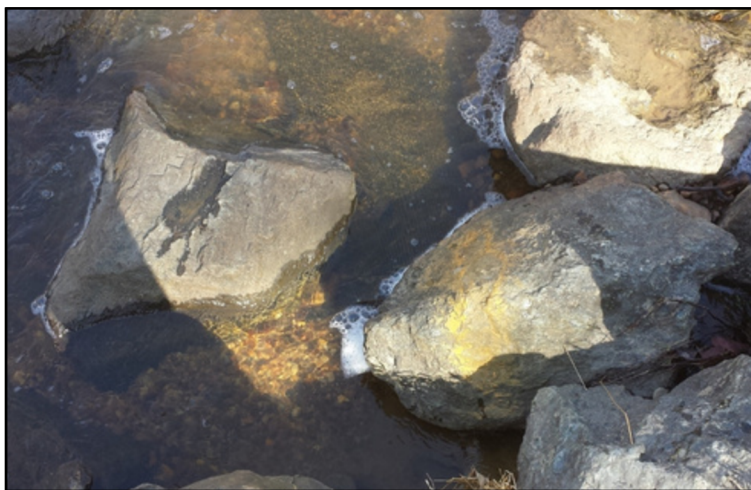
## BEFORE

A 22-inch diameter natural gas pipeline that crosses the northwest branch of the Anacostia River in Silver Spring, MD, had become exposed due to bank erosion and lateral migration of the channel. Previously placed rock failed to remediate the erosion issue. If left uncovered and unprotected, the pipeline risked further exposure and potential damage due to continued erosion.

After our construction crew sandblasted and recoated the pipeline to restore its integrity, they installed a system of our articulating concrete revetment mattresses over a woven geotextile material. The mats allow natural vegetation and retain the grade to prevent future stream bed degradation. Material from the stream bed then was placed on top of the mat system in the form of constructed riffles to dissipate stream velocity.

The crew then placed stones on the toe of the banks above the thalweg and installed a rock sill downstream of the mat system to aid in preventing further bed degradation. Upon completion of the final grading, the crew installed erosion control blanket on the banks and placed seed and straw (Best Management Practices).
