CASE STUDY

CAJON DEADMAN WASHOUT

San Bernardino County, California
Submar Project 17269

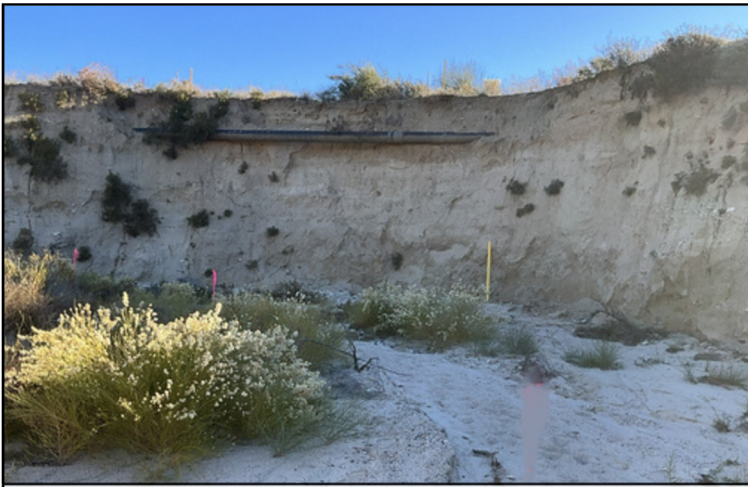
BEFORE

A 14-inch products pipeline runs parallel to an interstate in San Bernardino County, California. A nearby river has meandered towards the pipeline. Significant rainfall and run-off water have eroded the bank and undercut the pipeline, leaving the line exposed for 60 feet at a height of 17 feet.

The eroded bank of the riverbed was graded and built up with a compactable fill material. The pipeline was exposed, inspected, and recoated. Geotextile fabric and Pyramat 75 Turf Reinforcement Mat (TRM) were installed to stabilize the steep sloped riverbank. Both materials were locked into position with anchor trenches on all sides. Rip rap was installed along the toe of the riverbank to prevent future scour. Final grading was performed, seed and straw were placed on the disturbed area. During the second month after project completion, the site experienced an 11 inch rainfall in a 24 hour period, which resembled a 370-year storm. After this severe storm, the riverbank was intact and in stable condition as depicted in the top photograph.
