CASE STUDY

LAKE SAKAKAWEA

McKenzie & Williams Counties, North Dakota
Submar Project 14743

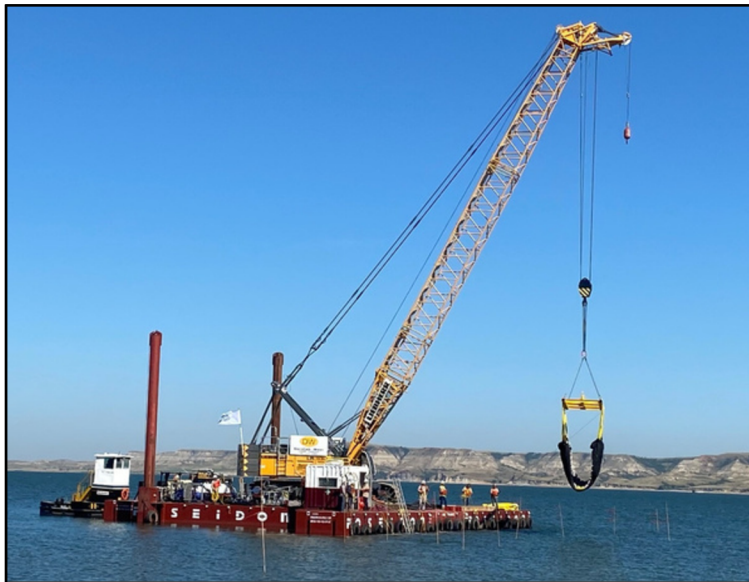
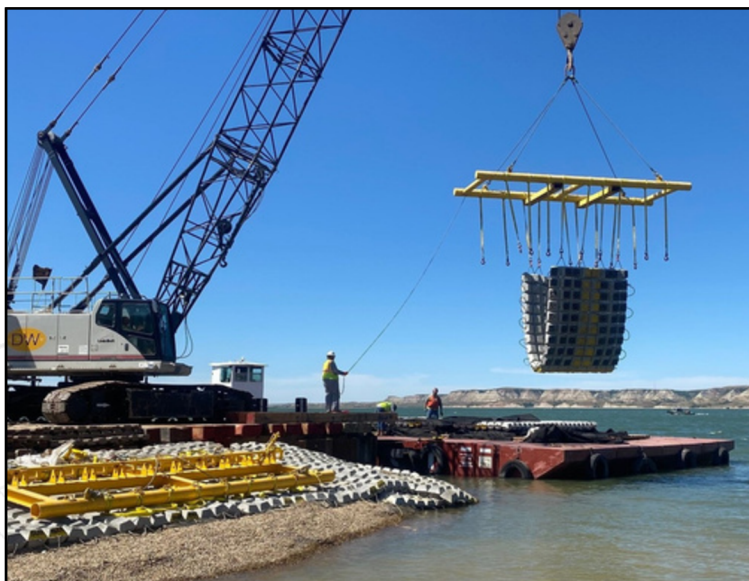
Concrete grout bags were placed under and around suspended sections of the pipeline for support. 340 (9-inch thick) articulated concrete mattresses were placed over the pipeline with a geotextile base layer for soil retention. A diving crew assisted in accurately placing mats and grout bags over the pipeline.
