EROSION CONTROL

Shoreline Protection Techniques

Combining technologies to stop ocean, lakefront, and channel erosion.

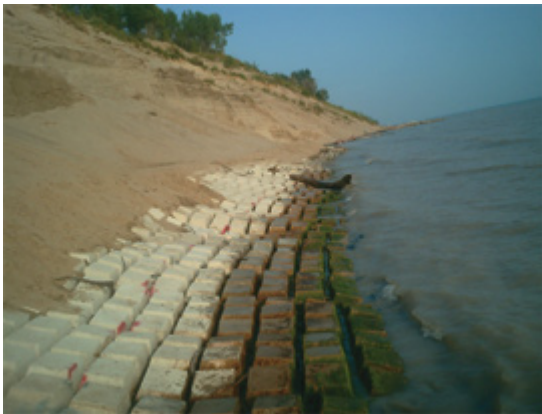
At Sand Hill Park on the Canadian side of Lake Erie, approximately 120 concrete mattresses 4 feet by 16 feet were installed to secure 400 feet of beach.

The IEC product, which Alton describes as "looking like giant ice-cube trays," is made from individual concrete blocks fastened together with stainless steel cable. For the Sand Hill project, two layers of fabric were placed underneath the mattresses to ensure there were no spaces. The concrete mattresses hold the sand and fabric in place. Each 4-foot-wide by 16-foot-long mattress was positioned vertically along the bank. Approximately half of the 16-foot length was positioned in the water, leaving about 8 feet of the mattress was above the water line. Another row of mattresses was placed horizontally on top to form a cap. In total, Alton says, it took approximately 120 of the mattresses to secure 400 feet of beach.

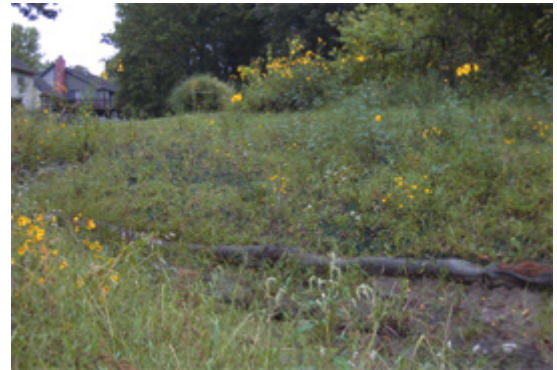
A coir log base with a wire turf reinforcement mat protects a slope.

Hite points to a recent project on Rock Creek in Gladstone, MO, as an example of successfully using soft and hard armor techniques together. "For this project, we used wire turf reinforcement mats [TRMs], gabions, and coir logs," he explains. "The creek was in an urban corridor and had caused a lot of flooding in the past because it could not take the water from the surrounding impervious area. To correct the problem, the stream was widened, the steeper slopes were reinforced with gabion baskets, and the shoreline on the flatter slopes was protected with coir logs and wire TRMs."

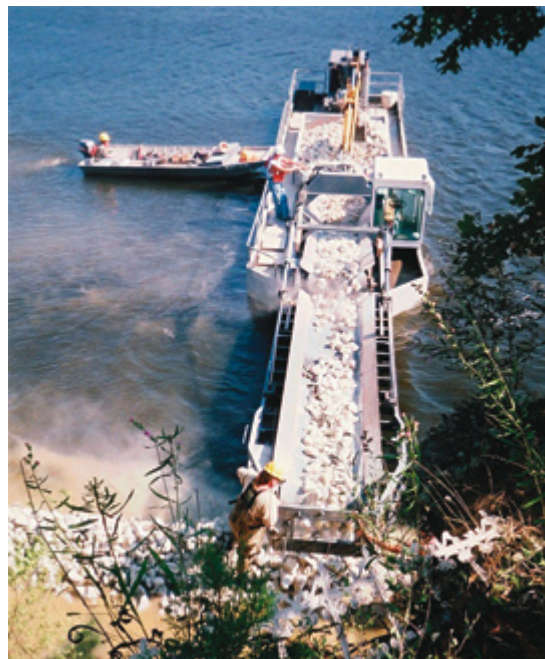
By working from the water, crews can avoid disturbing sensitive shoreline habitat.

Sutton says by operating from the water, workers do not have to disturb any of the natural forest or shoreline. "We don't want to damage the environment in any way, so working from the water is the best way for us to go. We also have the capability of hydroseeding when the bank behind the riprap reaches a stable slope."

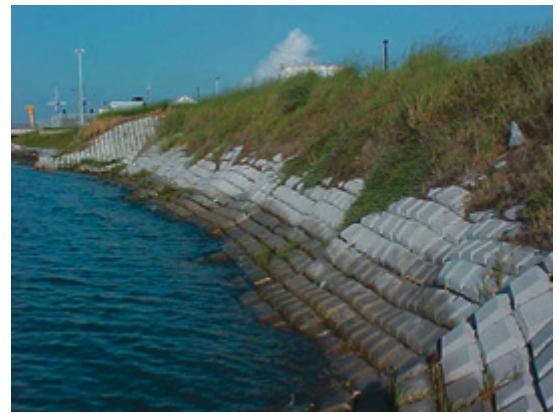
Articulated concrete revetment mats stopped erosion along the Corpus Christi Ship Channel in Texas.

Submar provided 800 feet of shoreline protection, providing both the materials and the labor for the project. The product used was **Submar**'s 4.5-inch revetment mats, articulating concrete mats with a low hydraulic profile. The mats measure 8 by 20 feet and are 4.5 inches thick, each weighing 6,200 pounds. Each has open areas that allow vegetation to grow through the mats, helping to create wildlife habitat and increased diversity in the areas where they are installed. **Submar** completed about 300 feet several years ago and finished the last 500 feet in early 2004, which took about seven days to install. They brought the mats in on trucks and then used heavy equipment to lay them in place. The mats extend from the top of the bank into the water, and the area has been seeded with native plants.

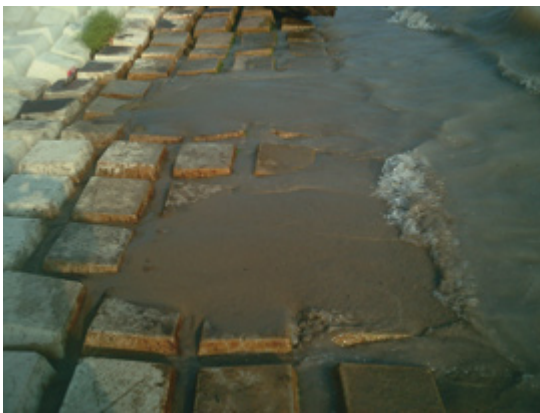
Concrete mattresses helped stabilize the shoreline at Sand Hill Park along Lake Erie.

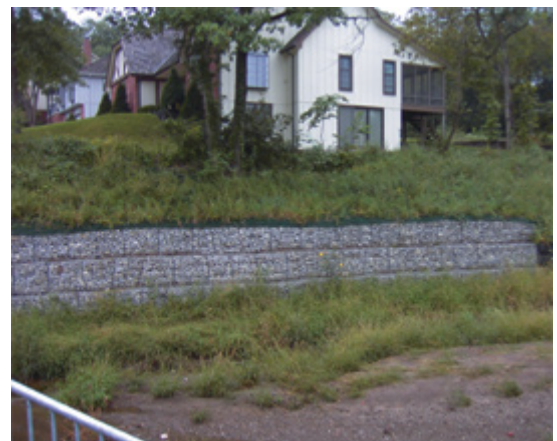
A gabion face and turf reinforcement mat on the top slope help reinforce the channel.
