EROSION CONTROL

Streambank Stabilization

Helping streams and channels withstand high-velocity flows.

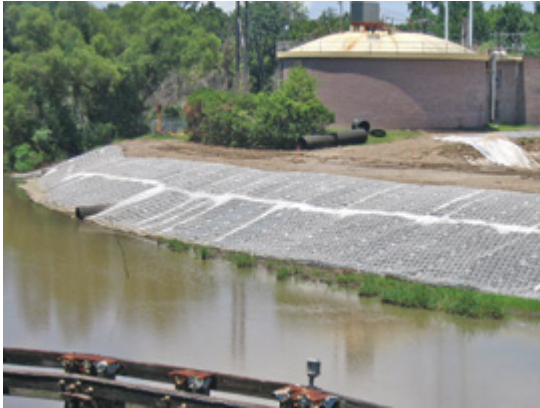
ACB protects a bank at a wastewater treatment plant.

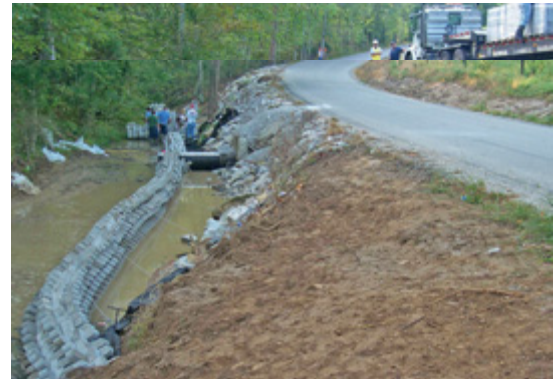
Embankment before project began PHOTO: ARMORTEC

The section of embankment adjacent to Taylor Branch, which runs parallel to the road, has an average horizontal width of approximately 4 to 5 feet, while the vertical depth from the top of the roadway surface to the bottom of the creek varied anywhere from 8 to 10 feet. "We think that over time, the stream continually migrated towards the roadway, and that is what started the failure," adds Hepner, who has been with the Kentucky DOT in the south-central part of the state for 23 years. "Once the erosion reached the loose soil, it just took over from there."

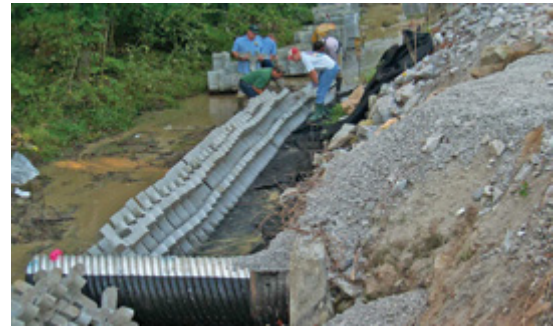
During A-Jacks installation

Hand-placing the A-Jacks in matrix

According to Hepner, a crew of 14 mobilized on September 20, 2005, and completed the job just two-and-a-half days later on September 22. "The A-Jacks units, which look like giant versions of the jacks kids used to play with, come in different sizes. For this job, we went with the 24-inch units, which are the smallest Armortec makes. These make up what essentially becomes the new toe of the embankment, and they are aligned in the streambed along the entire project."

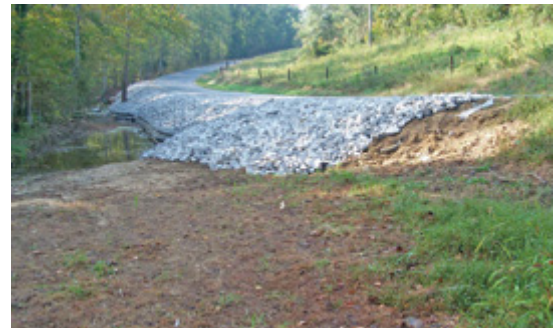
Finished Project

After the units were placed, Class II channel lining stone from a local quarry was delivered by dump truck and used to backfill the A-Jacks and rebuild the 8 to 10 vertical feet of embankment with a final 2:1 ratio slope. "In addition to the hard armor, we installed a geotextile filter fabric between the stone and the exposed soils throughout the project area," adds Hepner, who notes that all of the stakeholders are happy with the results. "So far, everyone is pleased with the project. The new streambank has not been challenged by a high-water event as of yet, but we have always been satisfied with how these systems have performed in the past, and I am sure we will be pleased with how they will perform on this application."

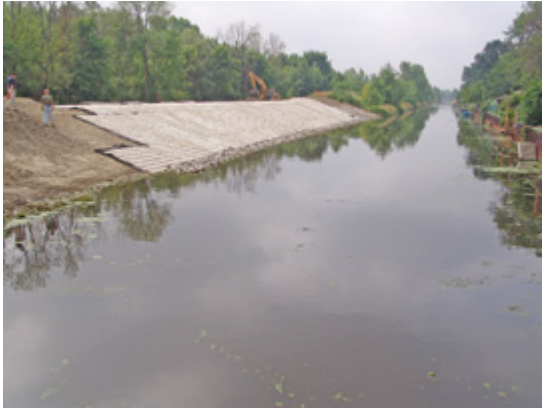
Weirs, serving as inlet and outlet controls for potential floodwaters, are protected from overtopping flows by concrete mats.

The concrete mats are draped over the berms or weirs and are submerged into the water to create a stable structure. Both the inlet weir and the outlet weir required 65 meters (approximately 200 feet) of the concrete mats. “We started the project in the late spring of 2005, and the installation was done over the summer,” notes Mourad. “International Erosion Control Systems supplied the mats, and our contractor placed them with an excavator. On the river side of the weir, they were anchored in a shallow trench on the river bottom and backfilled with riprap. On the land side of the weir, the mats were anchored in a shallow trench at the toe of the slope and backfilled with a few feet of clay. A geotextile filter fabric was also used underneath the mats.”

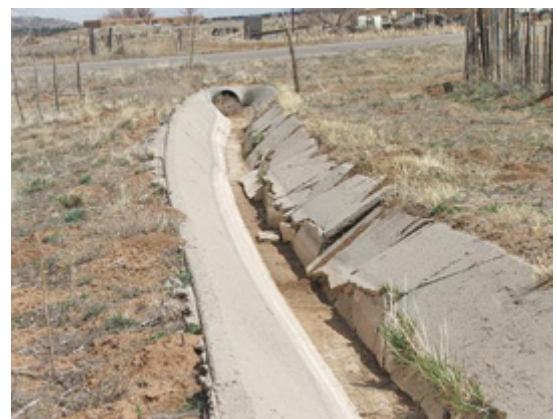
Broken lining allows water to leak from irrigation ditches.

Ken Suazo and his family have been working hard for the past 12 years to develop a method of conserving water that is transported through New Mexico's thousands of miles of irrigation ditches. Up until now, almost two-thirds of the water moving through the irrigation systems could be lost due to cracks and leaks in what are predominantly concrete-lined ditches. The solution Suazo came up with is a corrugated, high-density polyethylene product called SmartDitch, which can be used to line both old and new ditches, preventing erosion problems and minimizing leakage of the precious commodity that is used to irrigate the state's crops.

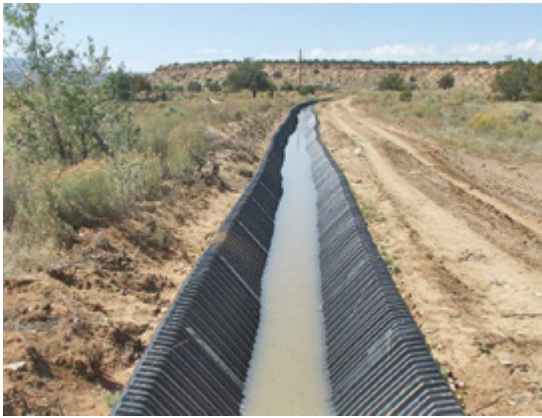
Flexible liner is installed over concrete liner using hand tools.

Installation of SmartDitch is fairly straightforward, and Suazo estimates that an experienced installation crew can install up to 1,300 linear feet on a good day. “The old concrete portions that have fallen into the ditch need to be removed, which can be done with a small excavator, but most of the existing concrete is left in place and then the banks have to be cleaned. The liner is delivered in 8-foot sections, which weigh about 50 pounds each and can easily be carried and positioned by two men. Once the liners have been placed in the ditch, they are connected with rivets and anchored using Better Built Earth Anchors, which are driven in with either a sledghammer or a hammer drill.”

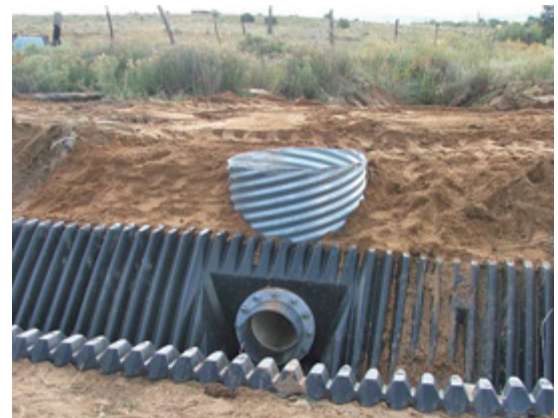
Crews can install up to 1,300 feet of liner per day.
