## **EXISTING CONDITIONS**

## **SOLUTION**

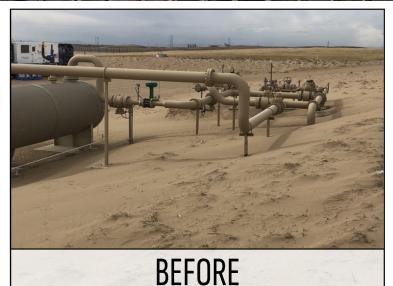
The site is a crude oil gathering facility in Weld County, Colorado within the DJ Basin. The soil is composed of mostly sandy material. Wind erosion was blowing sand all over the unit and sloughing off the hills. The proposed solution was to armor the embankment to minimize san erosion due to wind.

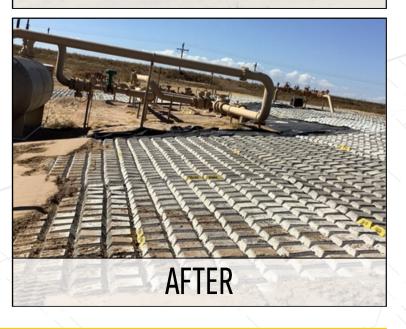
The site was graded and a geotextile material was placed on top of the grade. A Submar articulating concrete mat system (76 mats) was installed to armor the embankment. All edges of the mat system were toed into anchor and flank trenches that were backfilled with existing material and rip rap. Final grading was performed, seed and straw were placed on the disturbed area.
