## CASE STUDY

# LAS HUERTAS CREEK

Sandoval County, New Mexico  
*Submar Project 17549*

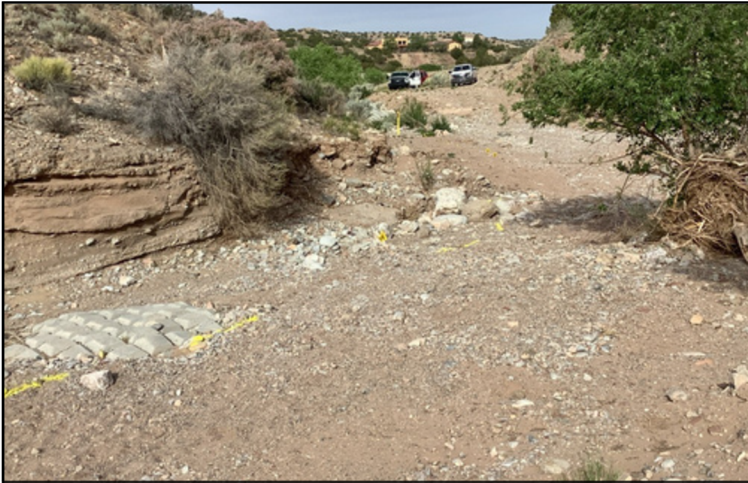
## BEFORE

A 50-foot wide pipeline right-of-way has one 30-inch natural gas pipeline that crosses Las Huertas Creek, Arroyo Channel, in Sandoval County, New Mexico. The Arroyo Channel had fairly steep banks composed of clay, sand, gravel, and rock and the pipeline had limited ground cover over an 1100-foot section. Further, the operator had partially protected the pipeline several times over fifteen years by placing several intermittent mats. The mats have become damaged, rolled up, and needed to be repaired and replaced due to improper installation.

Submar provided an engineered design to protect and armor the pipeline. First, the project area was graded and a geotextile material was placed atop the grade. Then, new Submar articulating concrete mats were installed and some were repaired throughout the entire 1100-foot section of the Las Huertas Creek. The edges of the mat system were toed into anchor trenches that were backfilled with existing material and rip rap. Final grading was performed to complete the project.
