CASE STUDY

RIVER ROAD EXPOSURE

Big Blue River in Indiana
Submar Project 15048

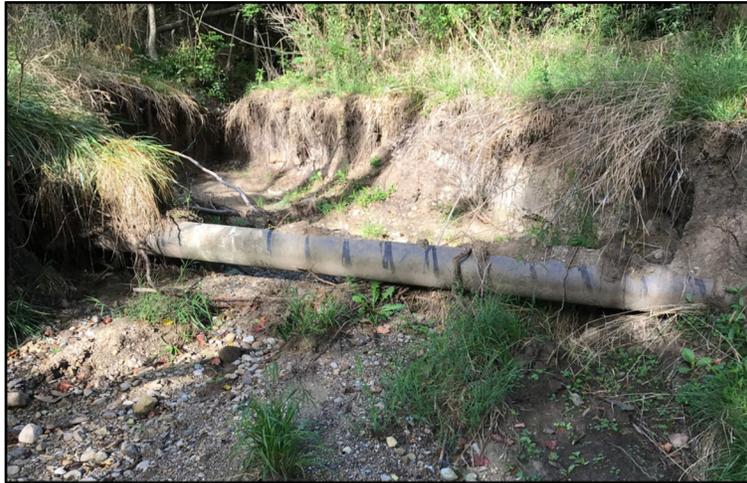
BEFORE

A 10-inch diameter natural gas pipeline crosses a tributary to Big Blue River in Indiana. A headcut -- an abrupt drop in the bed of the channel -- developed in a small drain that flows into Big Blue River and has exposed the pipeline for approximately 11 linear feet and left it suspended for approximately 12 linear feet. If left uncovered and unprotected, the pipeline risked further exposure and possible damage.
